**PHASE I  
ENVIRONMENTAL SITE  
ASSESSMENT REPORT**

**Section 2  
J-Pit Redevelopment Sites  
Gary, Indiana**

**SUBJECT: PHASE I ENVIRONMENTAL SITE ASSESSMENT  
SECTION 2  
J-PIT REDEVELOPMENT SITES  
GARY, INDIANA  
EDI Project No. 1216.001**

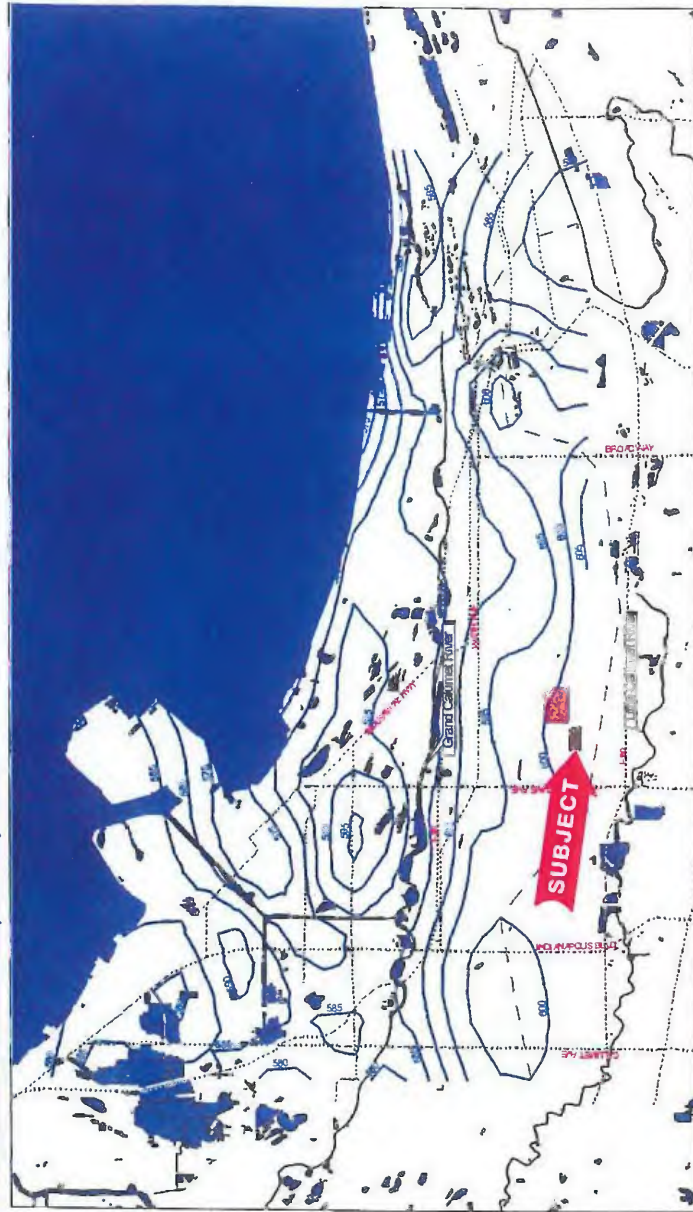
Figure 2 provides groundwater elevations in the Calumet Aquifer during March 1993 and October 1994. This map shows the subject property to be north of the groundwater divide between the Grand Calumet and Little Calumet River. In addition, the J-pit is adjacent north to the subject property. Therefore, the likely groundwater flow direction for the subject property is to the north. Localized groundwater flow can only be determined by installing monitoring wells. Based on this information, surface spillage of chemical, petroleum, or other potentially hazardous compounds on native soil in the area of the Property would have a high potential for impacting groundwater and extending beyond the initial area of contamination.

Ground Water Elevation, March, 1993

Ground Water Elevation, October 1994

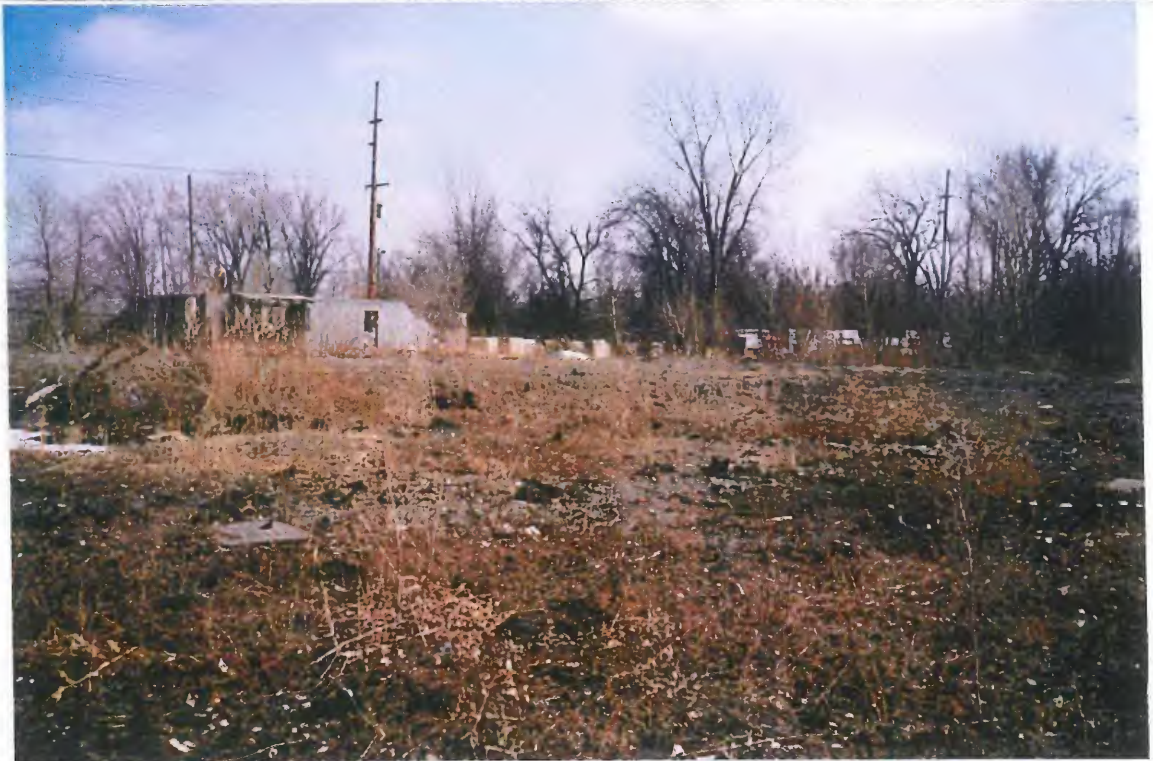
**PHOTO #1**

*View of eastern portion of subject property and pole mounted transformer as seen from the west.*

- **Polychlorinated Biphenyls:** Two pole-mounted transformers were observed on the east and central portion of the subject property. No other suspect polychlorinated biphenyl (PCB)-containing equipment was observed on the subject property.

Two pole-mounted transformers were observed on the eastern and central portion of the subject property. No other suspect PCB-containing equipment or materials were observed on the subject property.

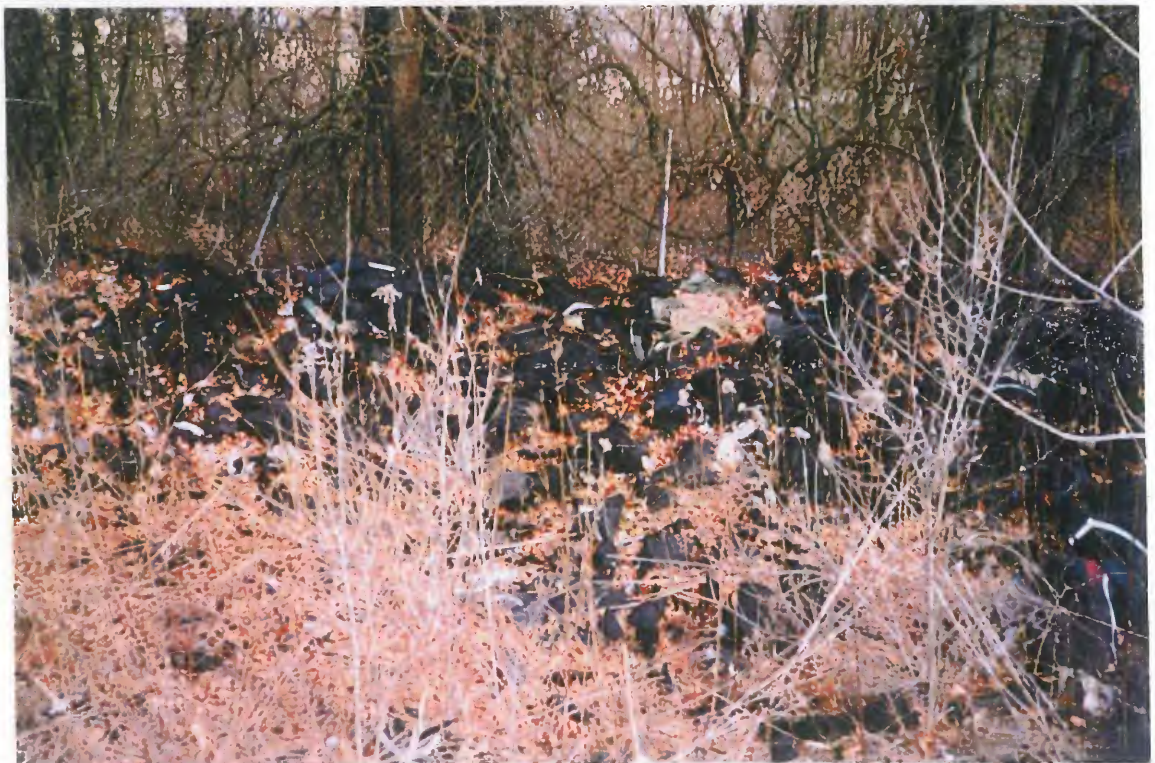
**PHOTO #2**

*View of shredded tires on the eastern portion of the subject property.*

- The surface and buried refuse noted on the subject property should be removed and properly disposed. A magnetic survey should be conducted to assess whether buried drums or USTs are present on the property.
- The eastern portion of the property was formerly Paul's Junkyard. The nature of the materials deposited in this area is unknown. There was stressed vegetation and oil staining noted throughout the eastern area. Soil sampling is recommended to determine if site soils have been negatively impacted by the operations of the junkyard.
- Historical records indicate that 2124 and 2150 Colfax were occupied by LeRoy's used autos in the 1960's. Soil sampling is recommended to determine if site soils have been negatively impacted by the operations of this business.

One 55-gallon drum, scrap metal, used and shredded tires, and general waste rubbish were observed throughout the subject property. No other materials handling, storage, or waste disposal practices of environmental concern were observed on the subject property.

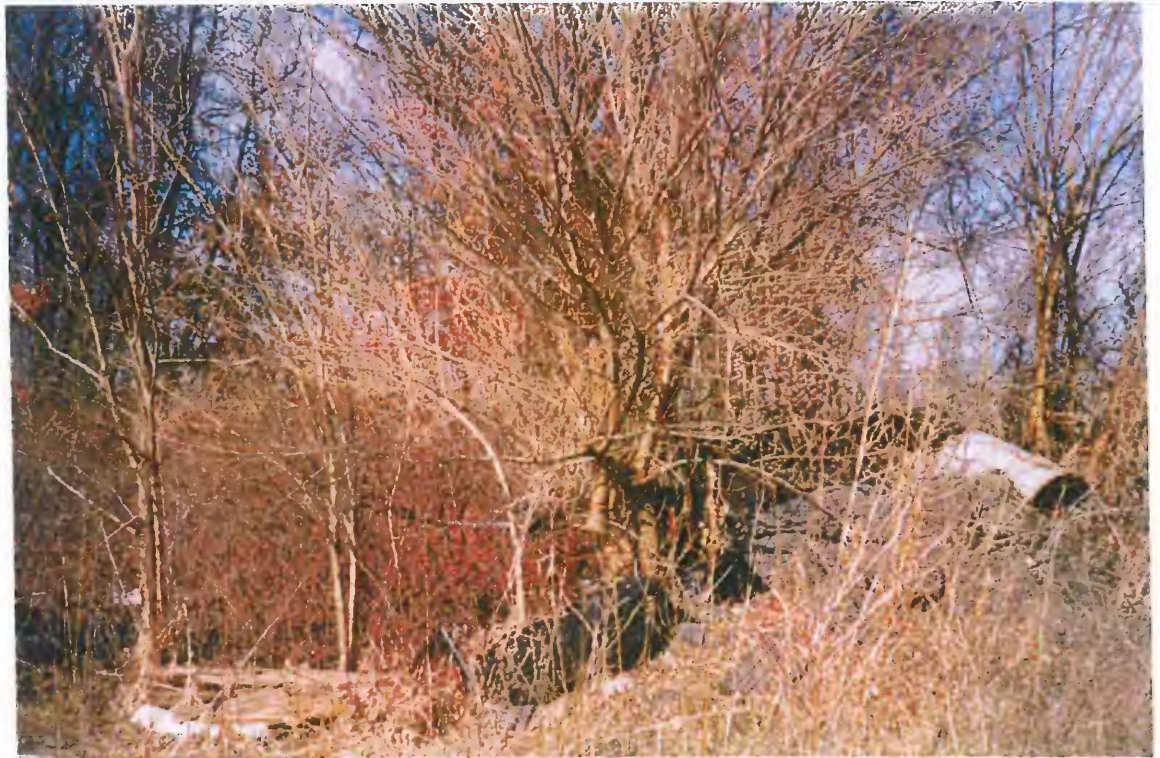
*PHOTO #3*

*55-gallon drum,  
debris and used tire  
on central portion of  
subject property.*

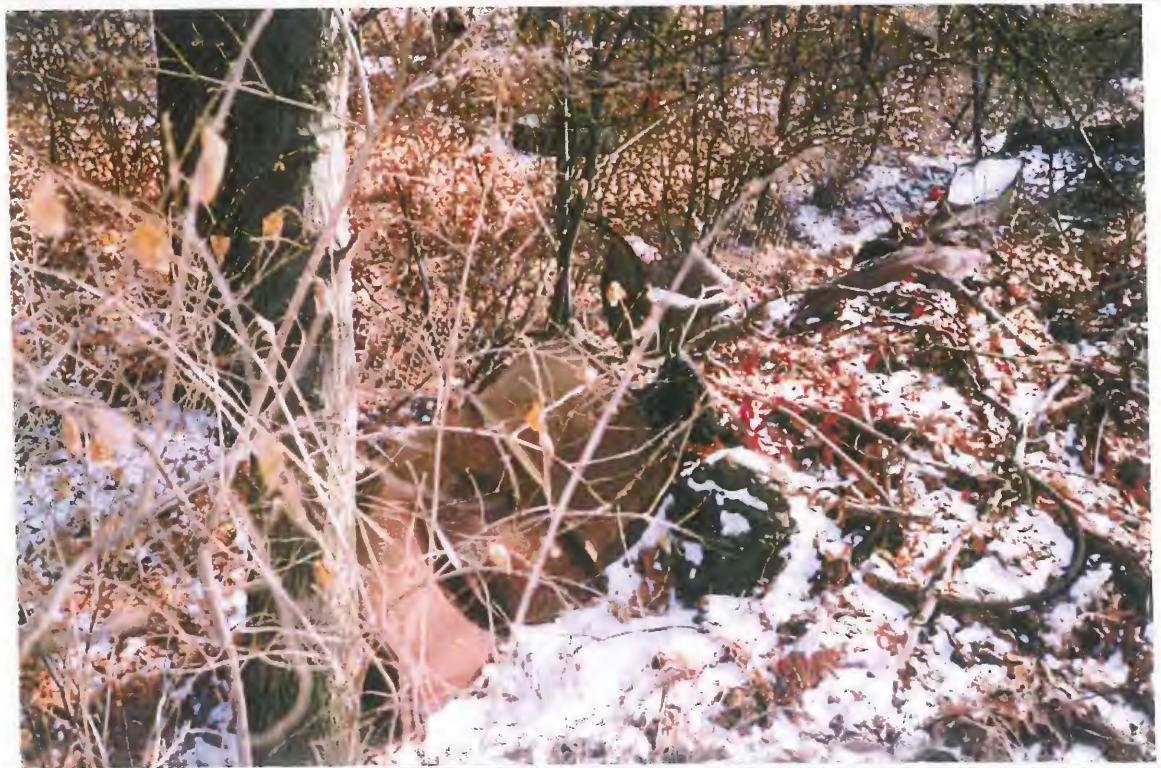
*PHOTO #4*

*View of southern  
border of north  
adjacent property.*

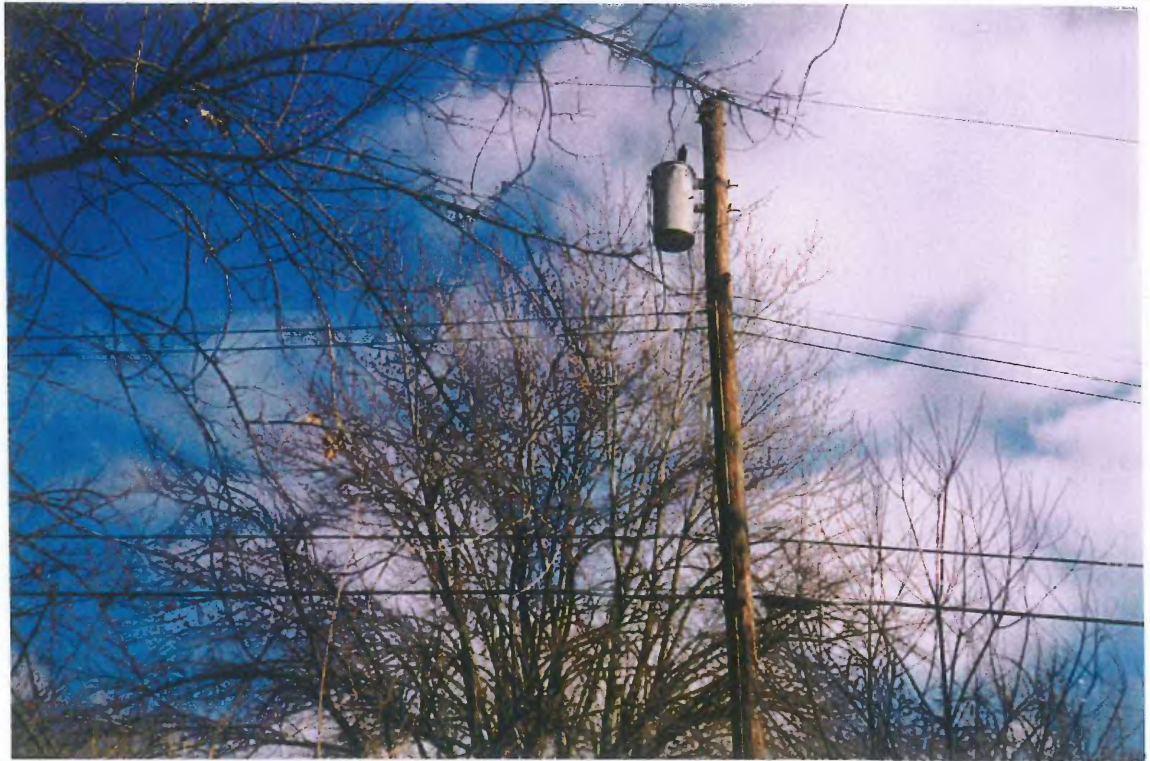
**PHOTO #5**

*View of pole mounted transformer located in the central portion of the subject property.*
